Manhole Inspection Summary

Manhole # S17K__007MH

Insp Date: **4/11/08 11:32 AM**

Location Address: **2501 helen st**

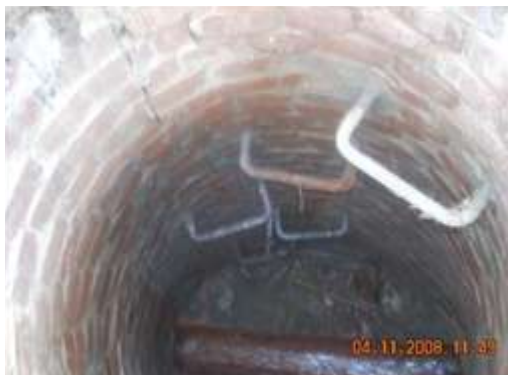
Defect 4

Steps Count: **5** Missing: **0** ☒ **Corroded**

corroded steps and bench debris

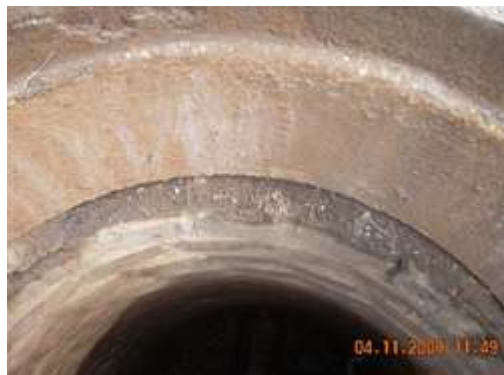
Defect 3

Frame Offset: **1** (in.) Condition: ☒ Sound ☐ Cracked ☐ Leaks

frame offset

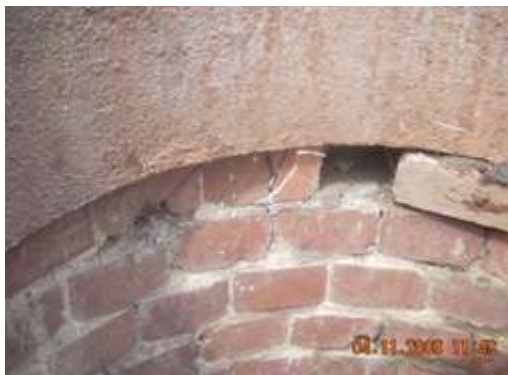
Defect 2

Condition: ☐ Sound ☒ **Cracked** ☐ Root Intrusion ☒ **Loose Brick** ☐ Deteriorated

cracked chimney brick

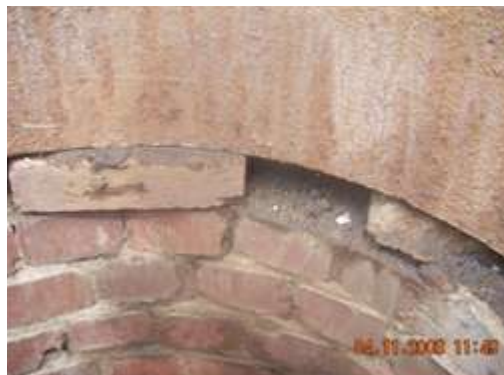
Defect 1

loose chimney brick

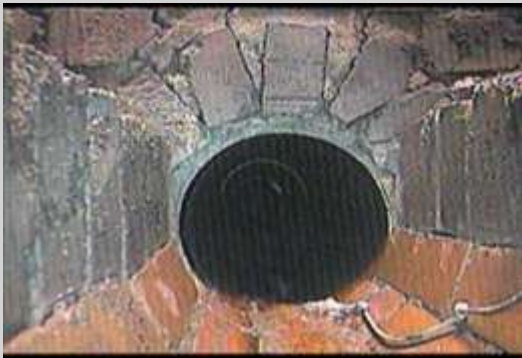
12 O'Clock Outflow

8 in. Circular Gravity Sewer
Pipe Out @ 12 O'Clock

Pipe Height: **8.4** (in.) Rod and Bar (Angled)
Pipe Material: **Clay** ☐ Pipe Lined
Invert Depth: **8.70** (ft.) Flow Characteristics: **Slow**
Deposits: ☒ None ☐ Mud ☐ Sludge ☐ Debris ☐ Grease
Silt Depth: **0** (in.) Deposits Extent:
Infiltration: **None** Pipe Seal Cond: **Sound**

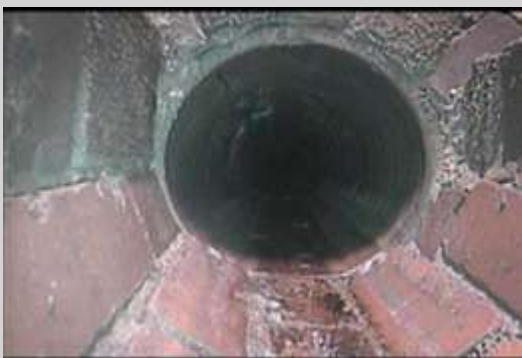
6 O'Clock Inflow

8 in. Circular Gravity Sewer
Pipe In @ 6 O'Clock

Pipe Height: **7.2** (in.) Rod and Bar (Angled)
Pipe Material: **Clay** ☐ Pipe Lined
Invert Depth: **8.40** (ft.) Flow Characteristics: **Slow**
Deposits: ☒ None ☐ Mud ☐ Sludge ☐ Debris ☐ Grease
Silt Depth: **0** (in.) Deposits Extent:
Infiltration: **None** Pipe Seal Cond: **Sound**
